## **Copper Loss from a Coppercoat Antifouling System over Time**

Report V7

| <b>Reference:</b> | PMA 257 |
| <b>Client:</b> | Coppercoat |

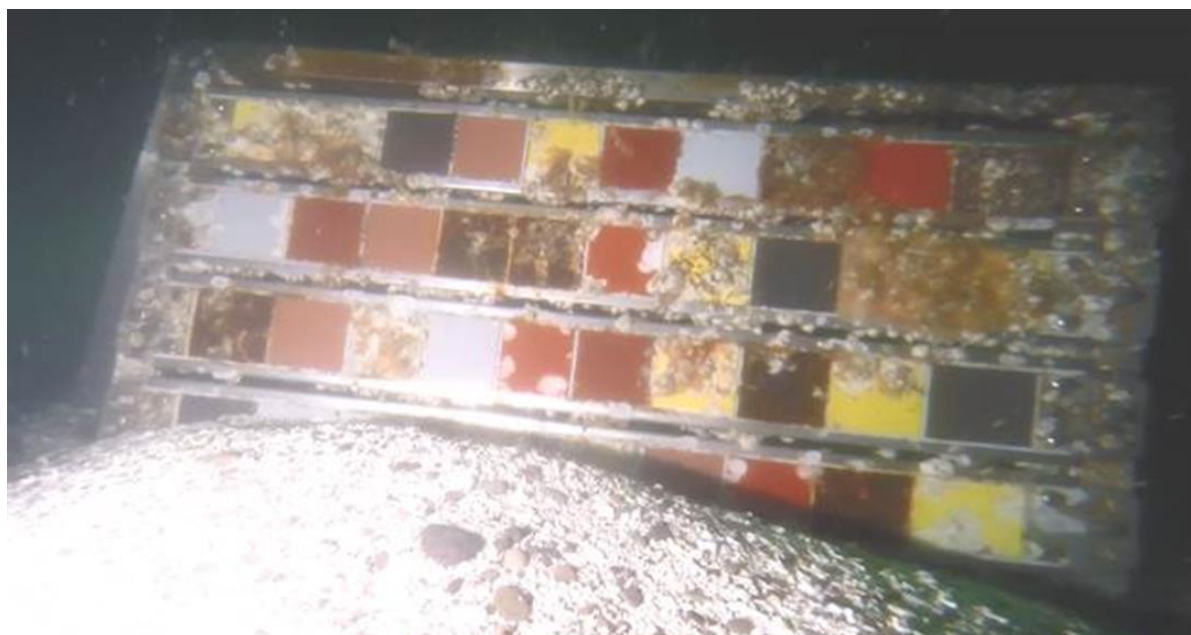
**Figure 2:** Still from ROV footage showing accumulation of debris against the bottom 2 rows of panels.

- On the east facing side the debris has built up to the extent that the concrete base and most of the bottom 2 rows of panels were obscured. Stones were also seen wedged between the rows of panels, suggesting that previously currents have been strong enough to lift and carry large debris which would have made contact with the panels even on the top row

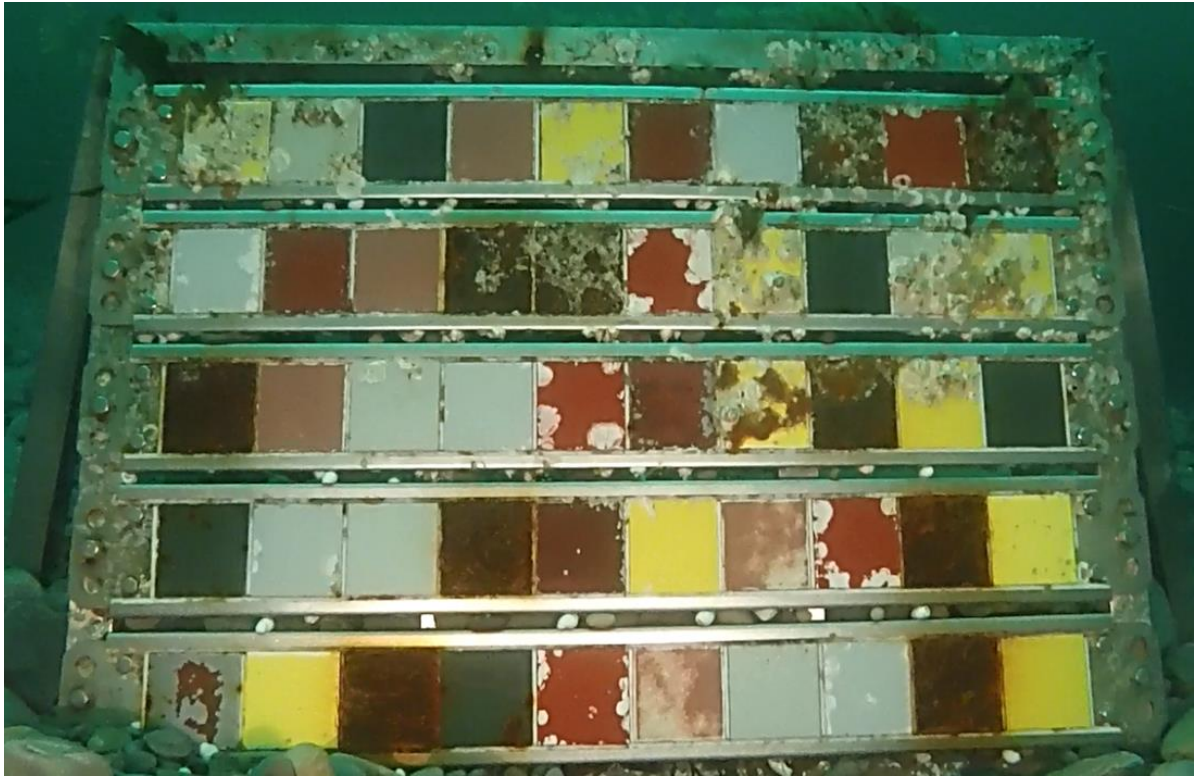
- Debris was clearly building up around the lander on the 2015 survey, but was much less evident on the 2016 visit. The lander did not appear to be in a depression, and no banking of debris was seen against the sides therefore it was decided that the lander should remain in that current position and not be lifted and moved.
- Five rows of panels were visible on the east side, as opposed to three the previous year. However the bottom row on the west side was then mostly obscured by debris.
- It seems likely that debris possibly increases and decreases periodically around the lander. The panels were clearly still being subjected to scouring by debris picked up and carried in strong currents, and to a larger extent than seen in 2015. While fouling levels in 2016 were generally at lower levels than seen in 2015, possibly due to scouring, damage to panels was still of great interest.

**Figure 3:** Still of deployed pod from ROV footage in 2016.

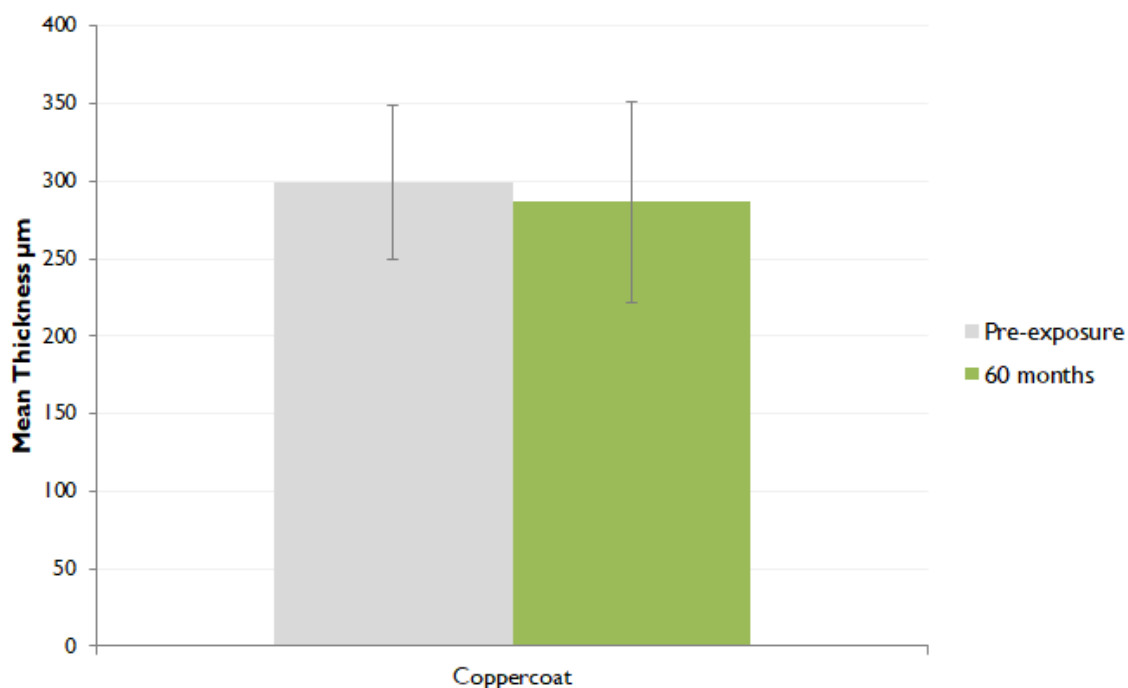
Coppercoat showed little significant change in thickness over time, excluding inter-panel variability.

**Figure 6:** Mean coating thickness pre-exposure and at 60 months. Error bars show standard deviation, and n=144 & 70 respectively.

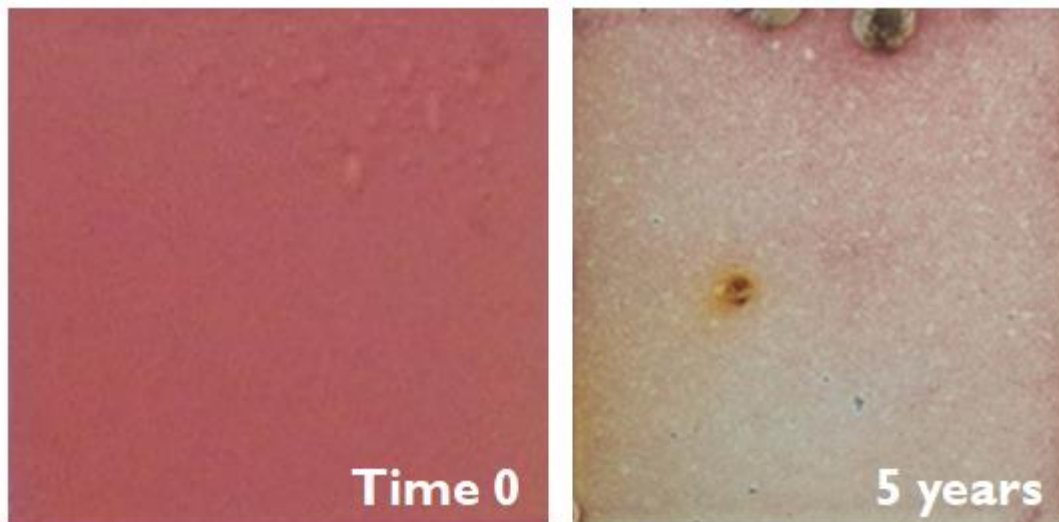
As stated by the manufacture, the top coat of the competitor brand was assumed to have an average thickness of 125  $\mu\text{m}$ . From our results, therefore, we can assume that by the end of the testing period of 5 years between 90 and 100% of the top coat, and up to 106  $\mu\text{m}$  (17% - tie coat loss  $\cdot$  100 / start thickness) of tie coat had been lost from this self-polishing system.

**Figure 8:** Top coat loss over 5 years – Self polishing anonymous coating system.
